# **Understanding CPU Lock-Up Mechanisms in UCD31xx Devices**

## **ABSTRACT**

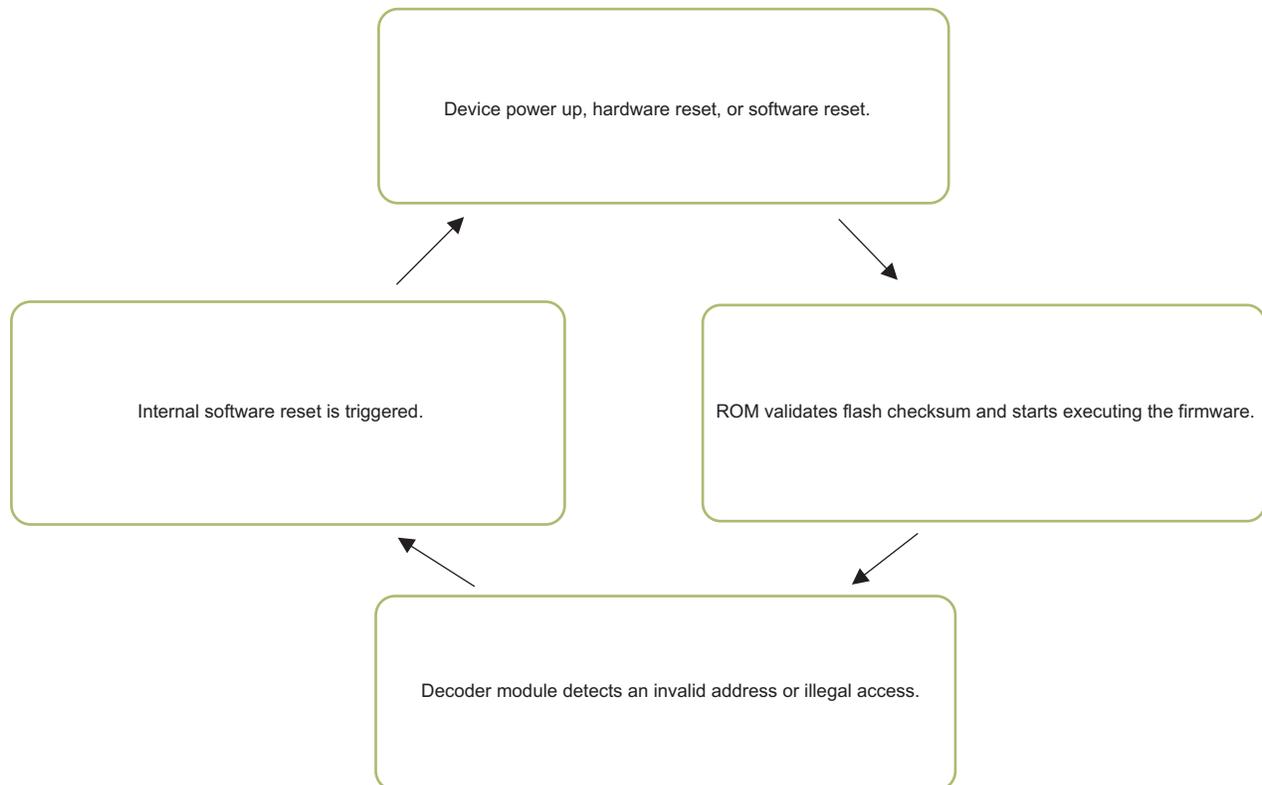
**Figure 1. Reset Loop Mechanism**

If the CPU reads or writes to an invalid address, or tries an illegal access, or does not service the timer watchdog periodically, the following sequence results in a *reset loop* and the device does not perform the expected programming behavior.

The current consumed by the device is different for ROM and flash modes. When the device is stuck in a reset loop, it alternates between the ROM and flash modes. The simplest debug procedure to determine if a device is stuck in a reset loop is to probe the current consumption on an oscilloscope.
